IIW document XV-1714-2025 for 78<sup>th</sup> IIW Annual Assembly, Genoa, Italy, 2025

# DED-COMPONENT DESIGN, MANUFACTURING AND PERFORMANCE AS PART OF STRUCTURE

Kalle Lipiäinen, Hannu Lund, Sakari Penttilä, Tomi Suikkari, Juha Peippo, Juuso Raitila, Antti Ahola, Tuomas Skriko

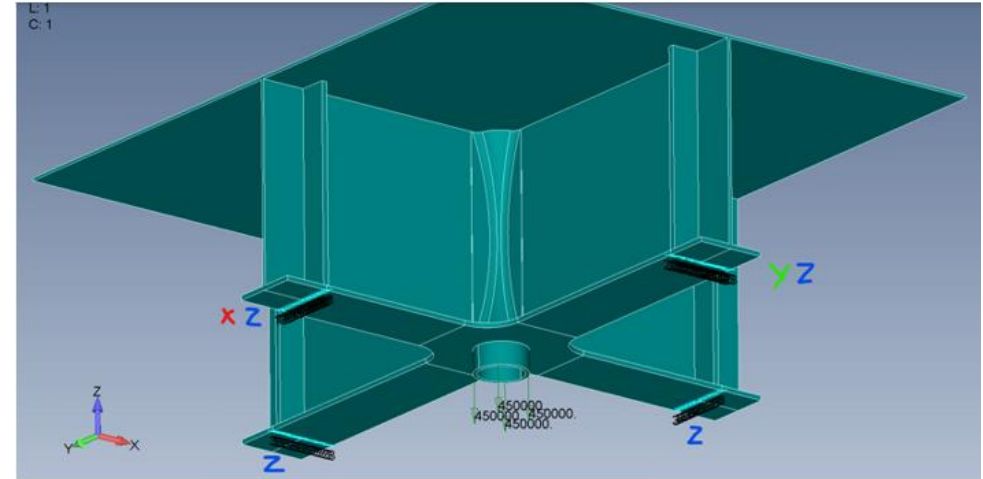
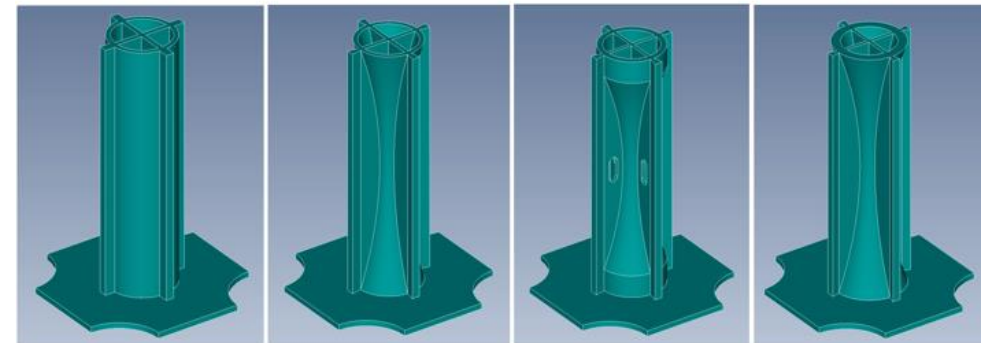
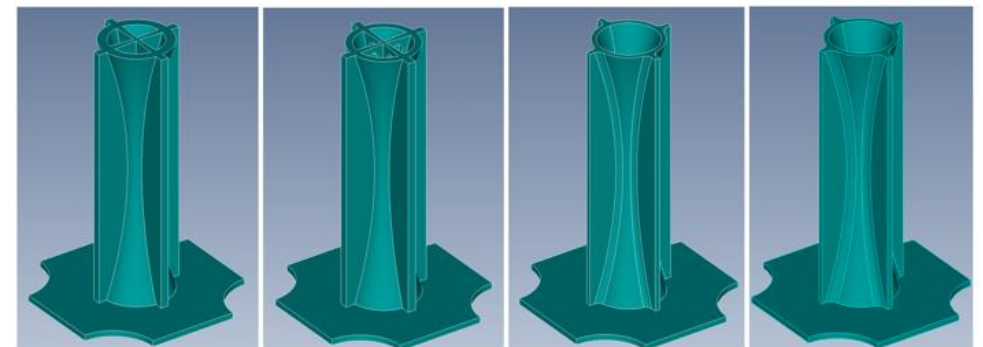
- Finite element analysis (FEA) for initial screening for optimal weight and design
- Manufacturability considerations during design

(a) Weight  $\approx$  17,91 kg

(b) Weight  $\approx$  12,08kg

(c) Weight  $\approx$  12,66 kg

(d) Weight  $\approx$  13,03 kg

(e) Weight  $\approx$  15,80 kg

(f) Weight  $\approx$  13,63 kg

(g) Weight  $\approx$  9,94 kg

(h) Weight  $\approx$  10,23 kg

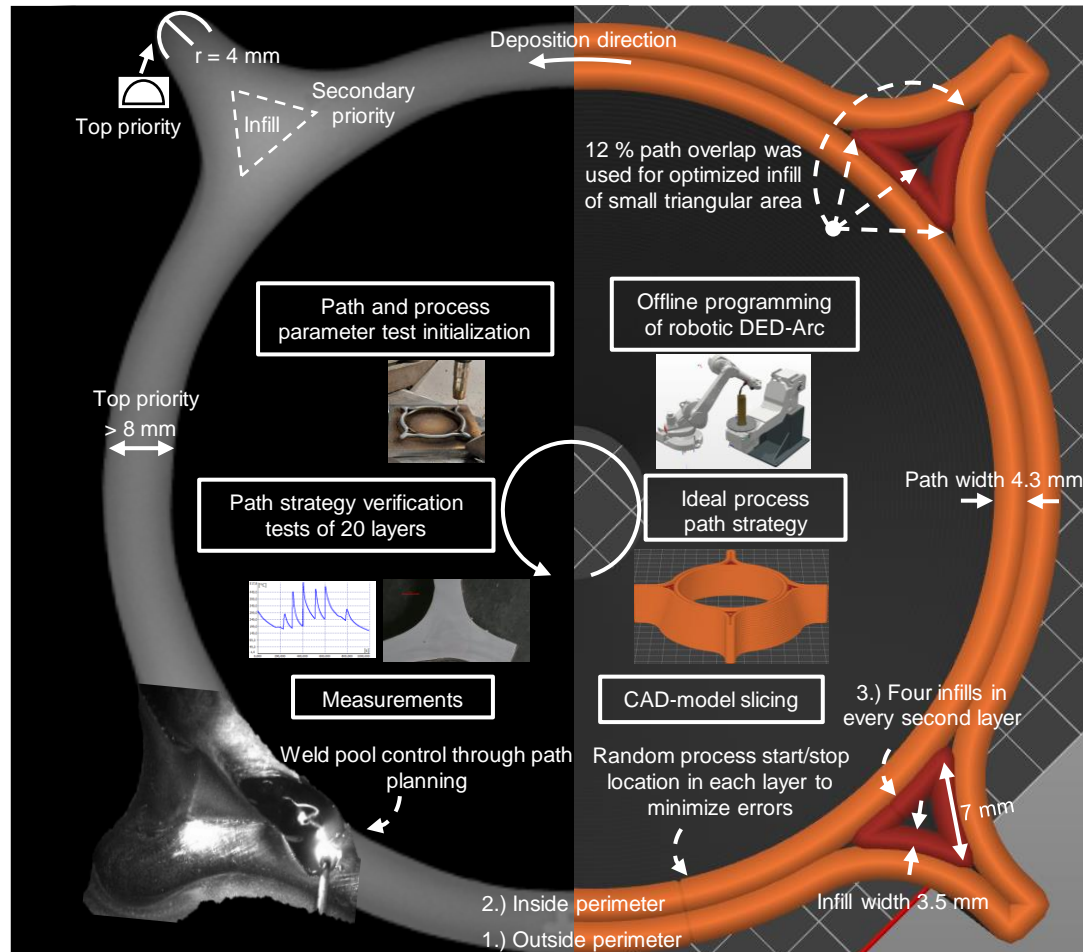
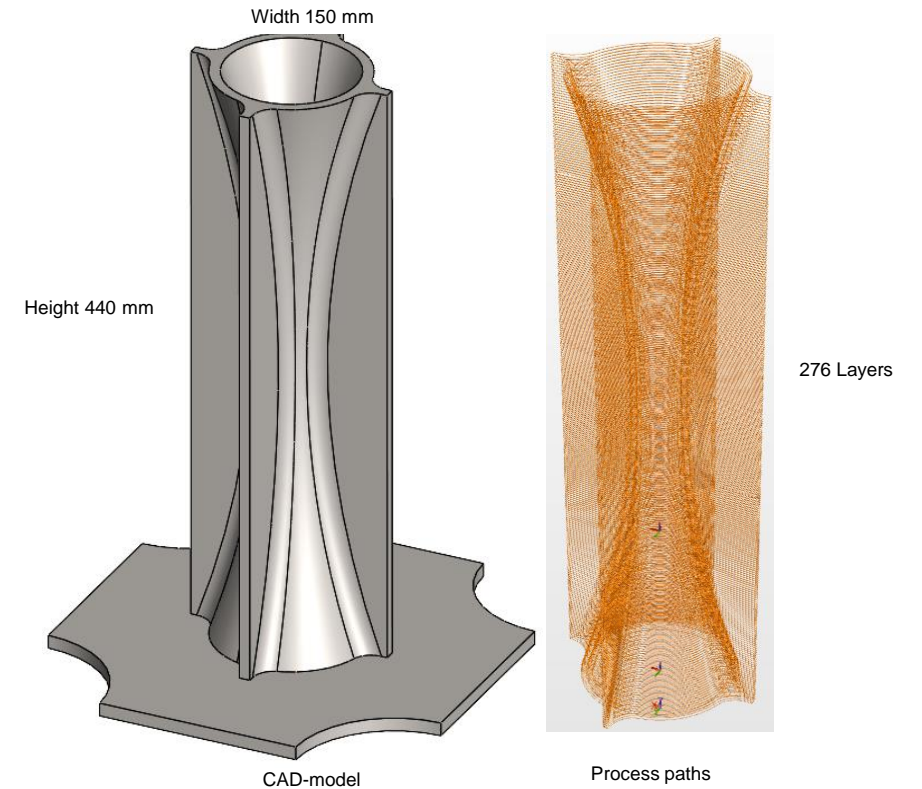
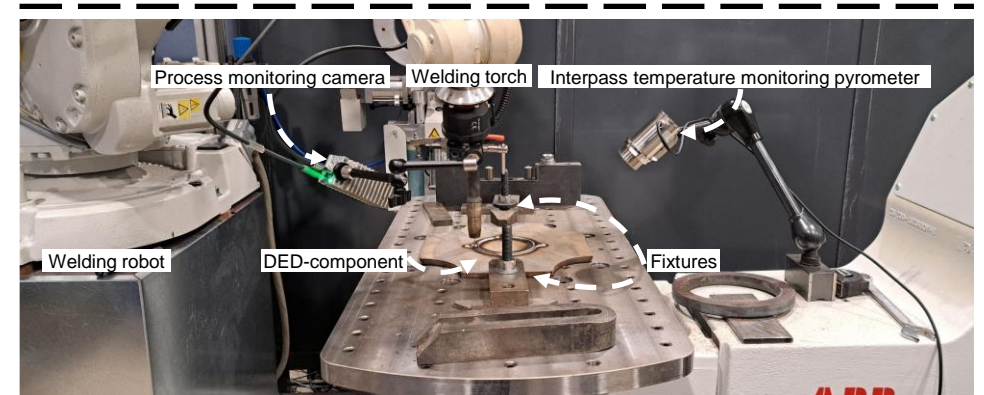
# MANUFACTURING

- Directed energy deposition (DED) was selected due to cost efficiency potential
- DED-Arc-wire method specifically – Also known as WAAM

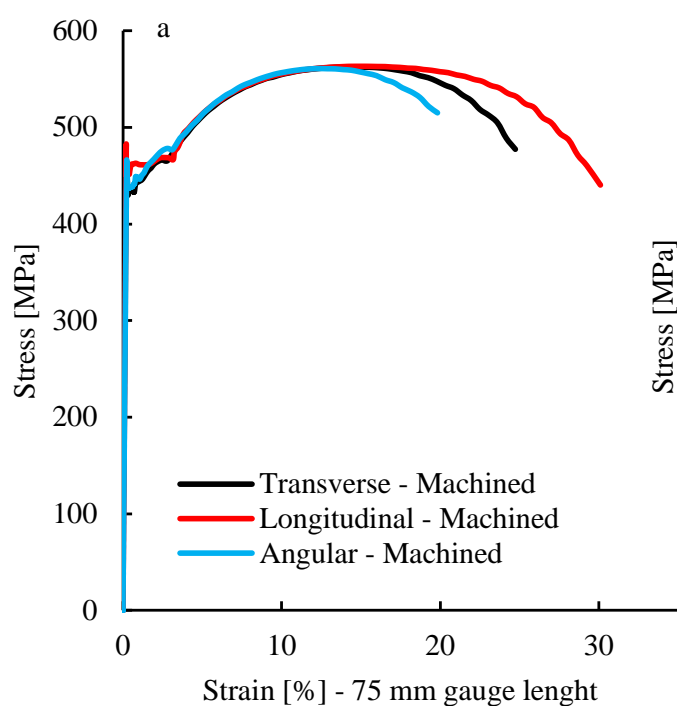
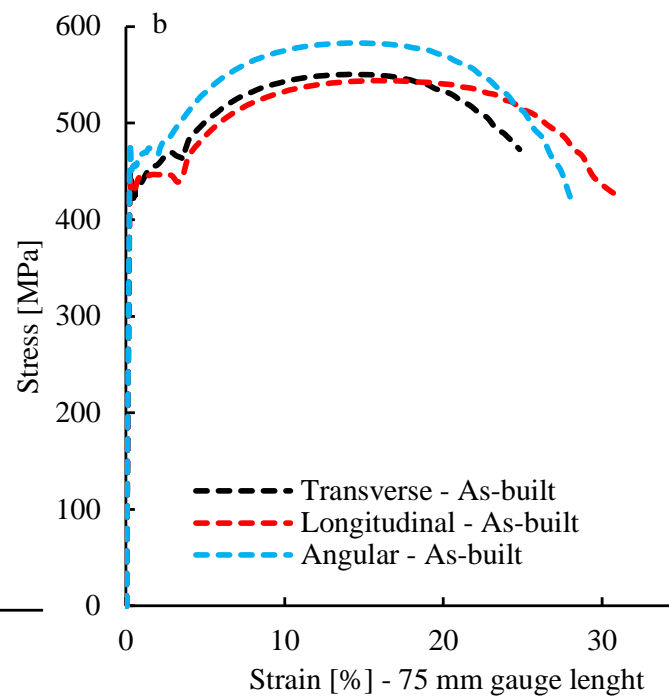
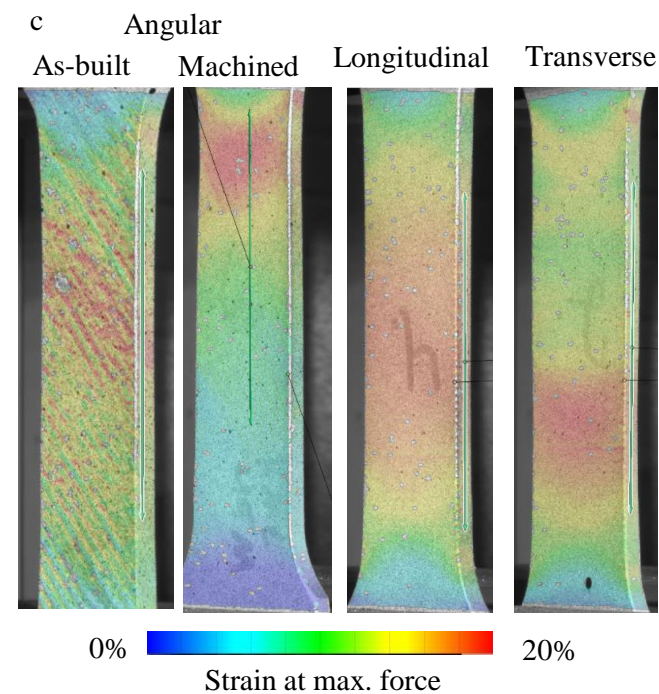
# TENSILE STRENGTH

- Low strength filler wire (Elga Elgamic 100) used
- Low cost (3-4e/kg) and matches to rest of ship structure

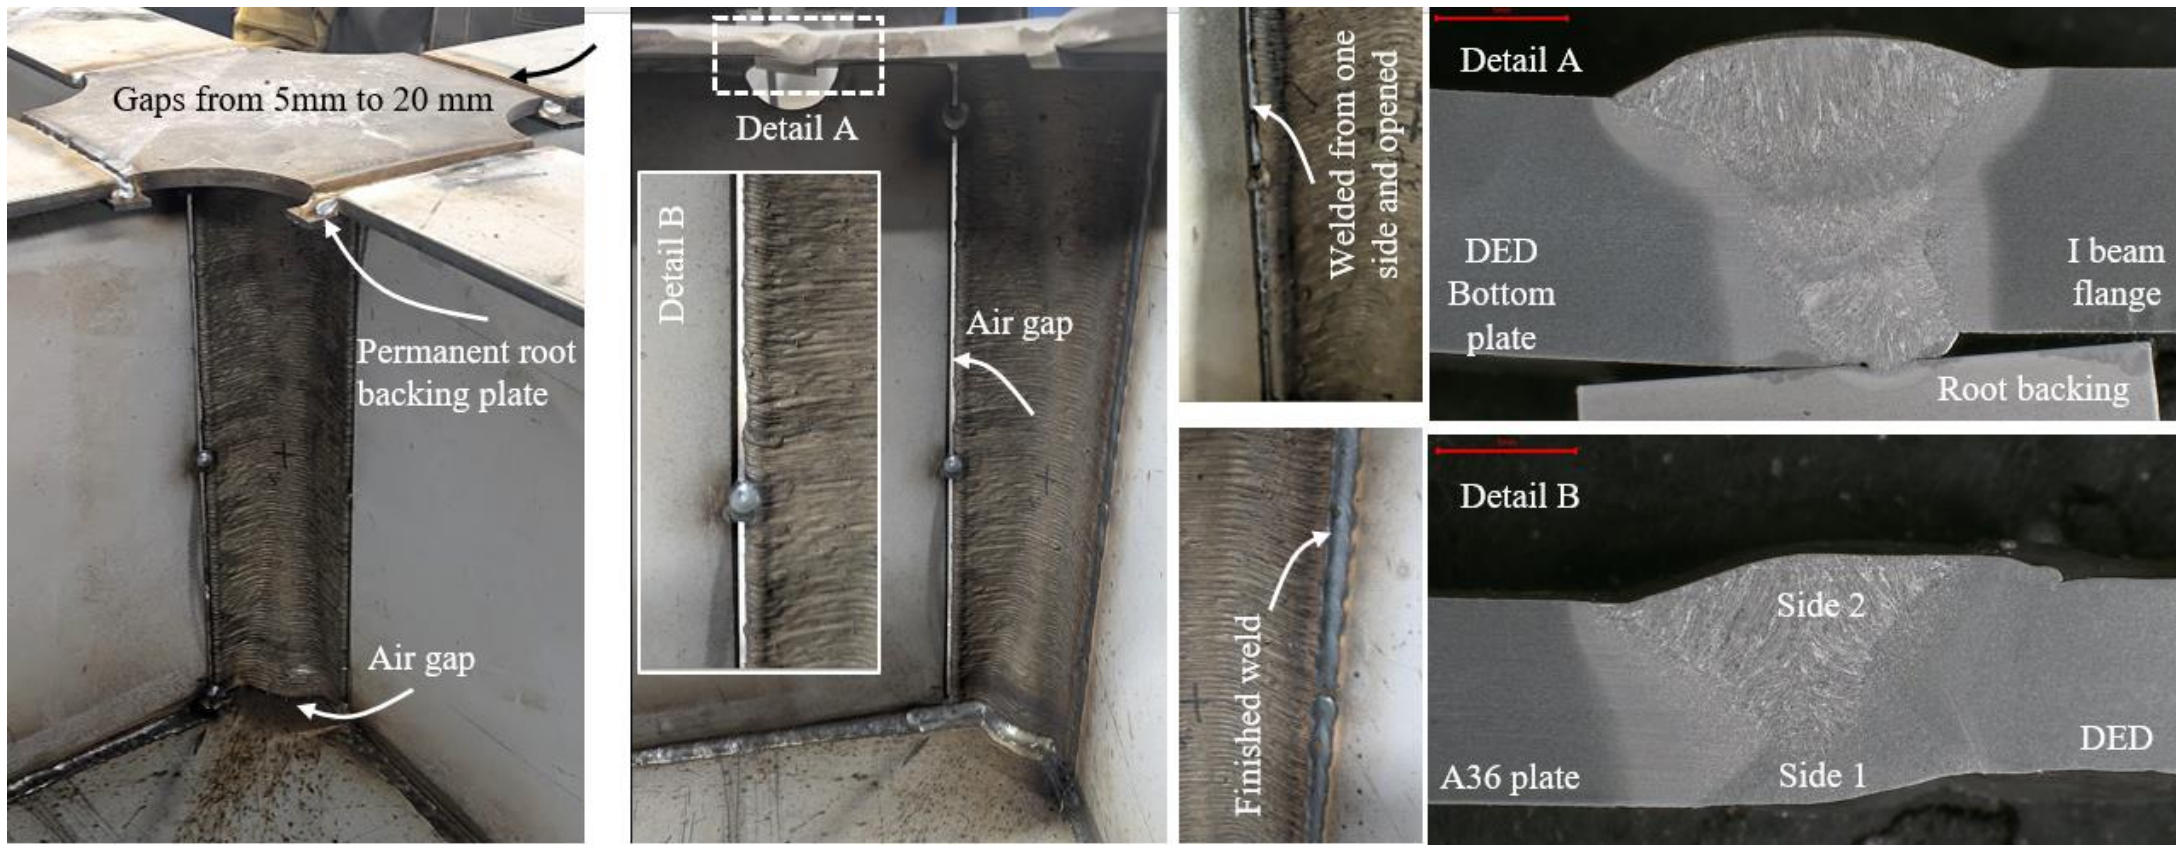
# ASSEMBLY

- Assembly in realistic position (as photographed) with GMAW – Tolerance handling important
- Root backing used for diamond plate to handle 5-20 mm gaps

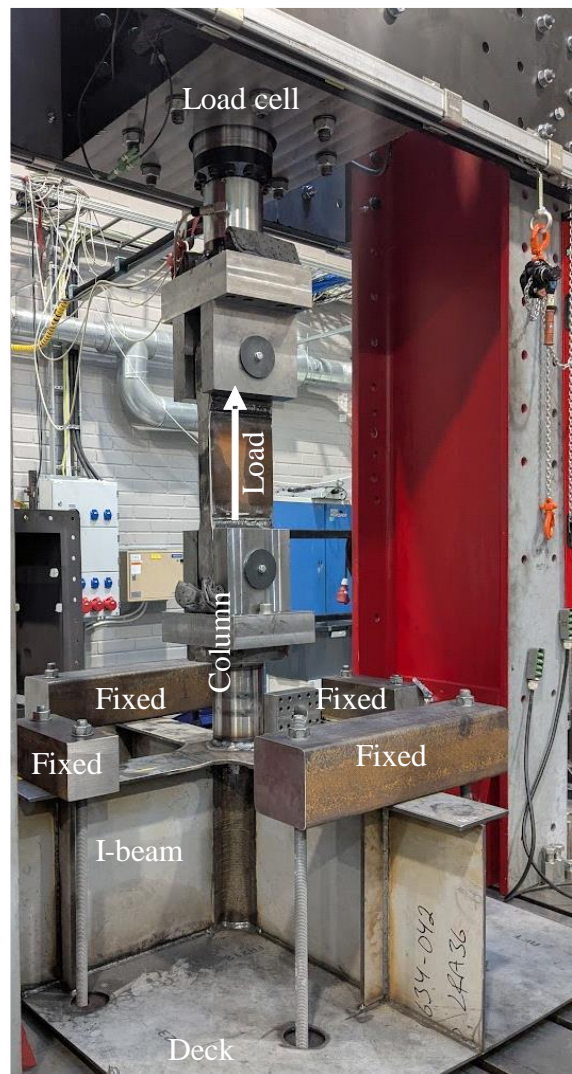
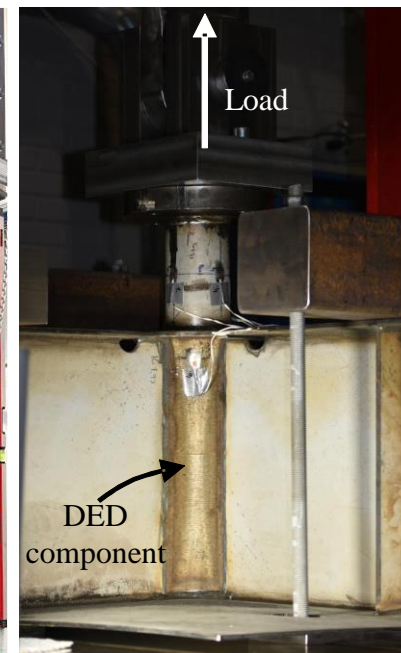
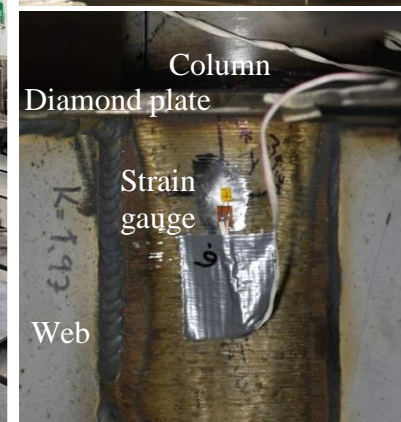
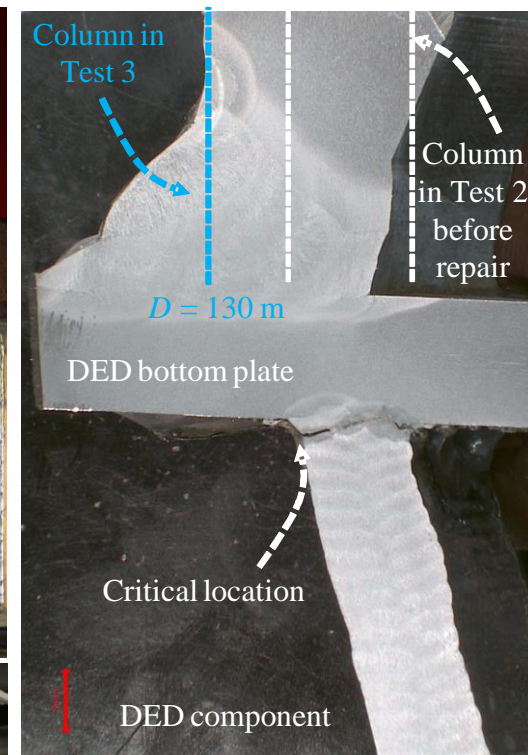
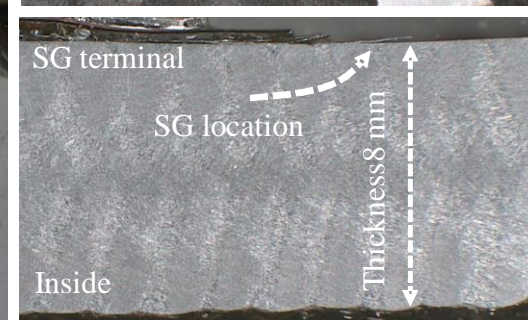
# FATIGUE TESTING

- Full-scale test to study performance
- $R = 0$  stress ratio loading
- Multiple test and repair after Test 2
- Total >1 000 000 cycles
- Test 2 was found to start crack propagation in DED component
- Test 3 after column repair for fatigue crack propagation in DED component

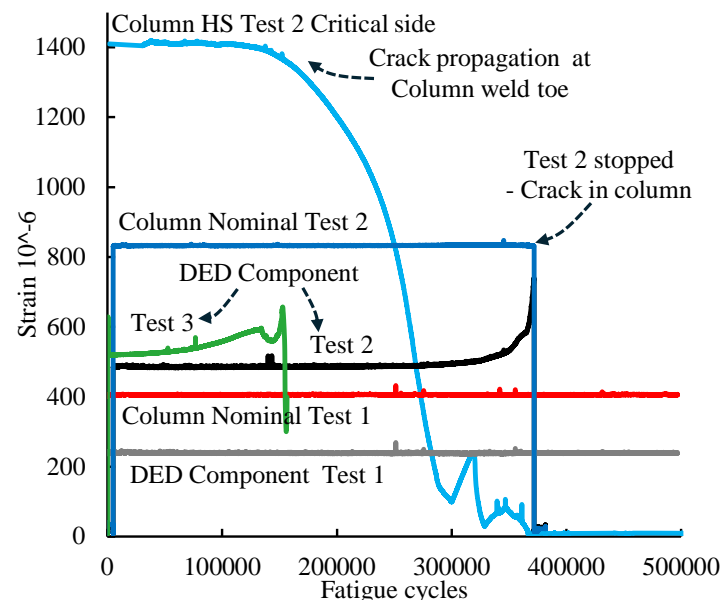
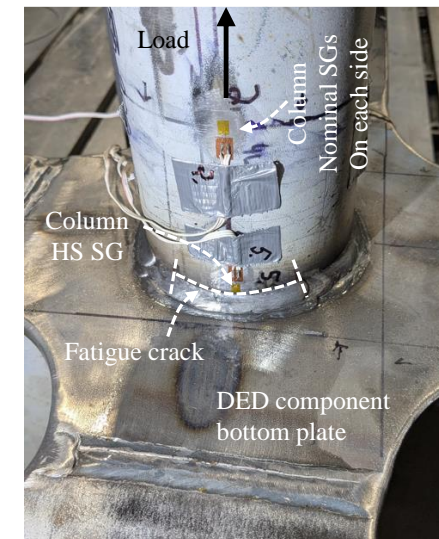
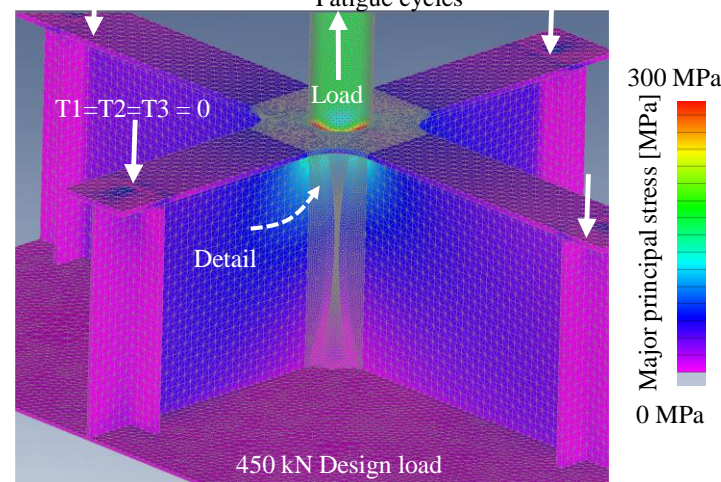
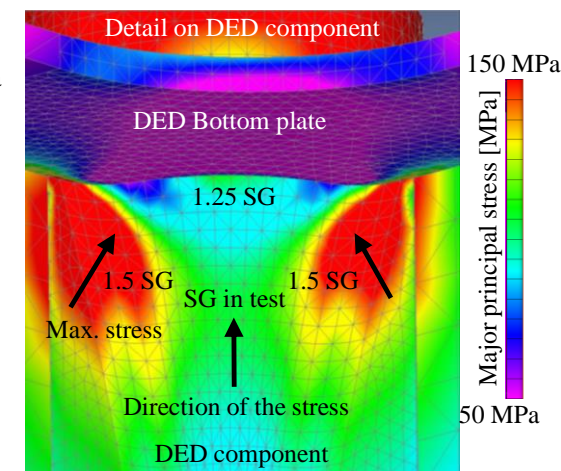
# STRESSES IN FATIGUE TEST

- ▶▶ Hot spot (HS) stress evaluation in case of column weld toe fatigue crack (Test 1 and 2)
- ▶▶  $\Delta\sigma_{c,50\%} = 152 \text{ MPa}$  ( $m = 3$ ) for weld toe
  - ▶▶ Reference value 137 MPa – Inline with IIW recommendations
- ▶▶ Stress in DED component monitored by strain gauges and FEA

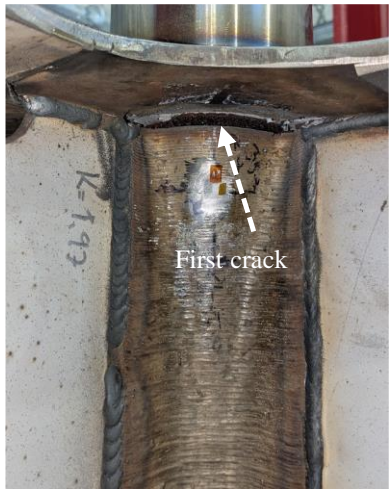
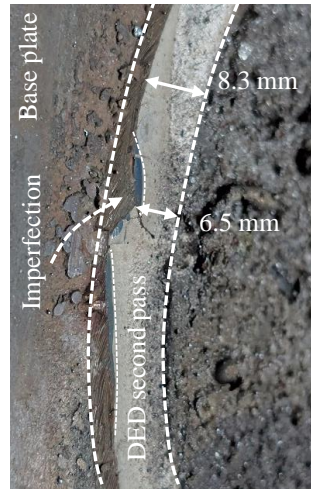
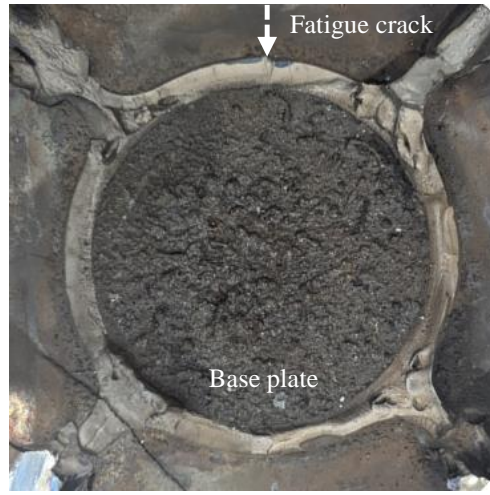
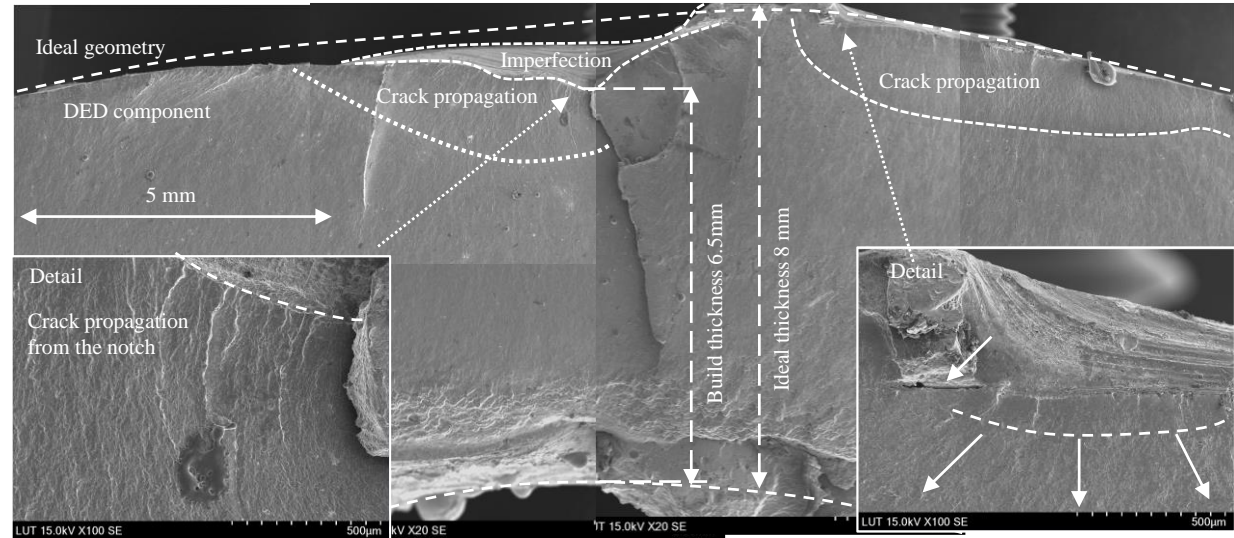
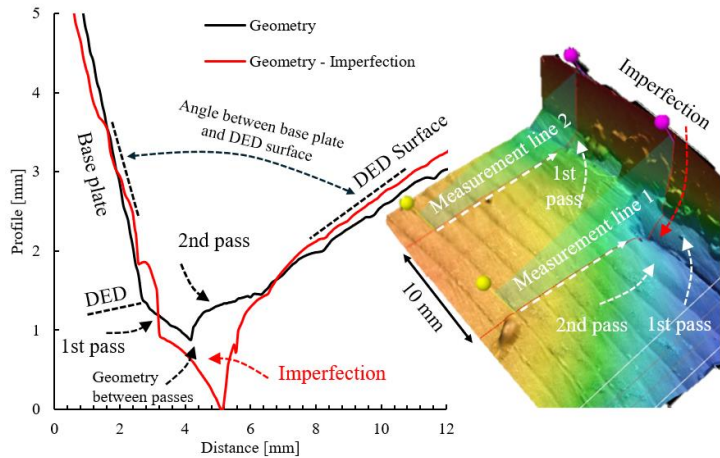
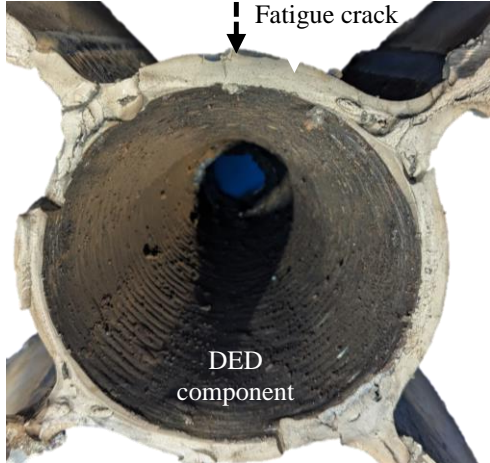
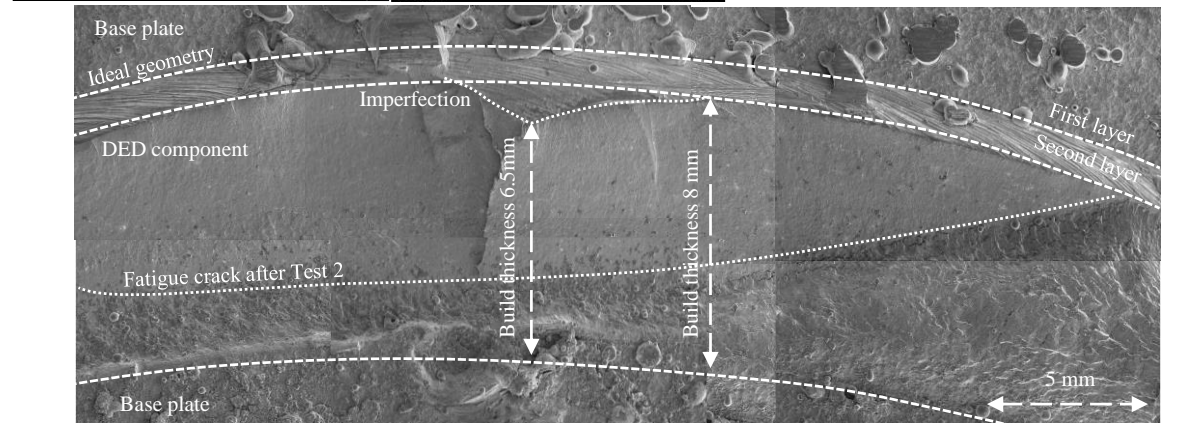
# FAILURE ANALYSIS

➤ Visual and SEM combined – Imperfection caused increase in local stress

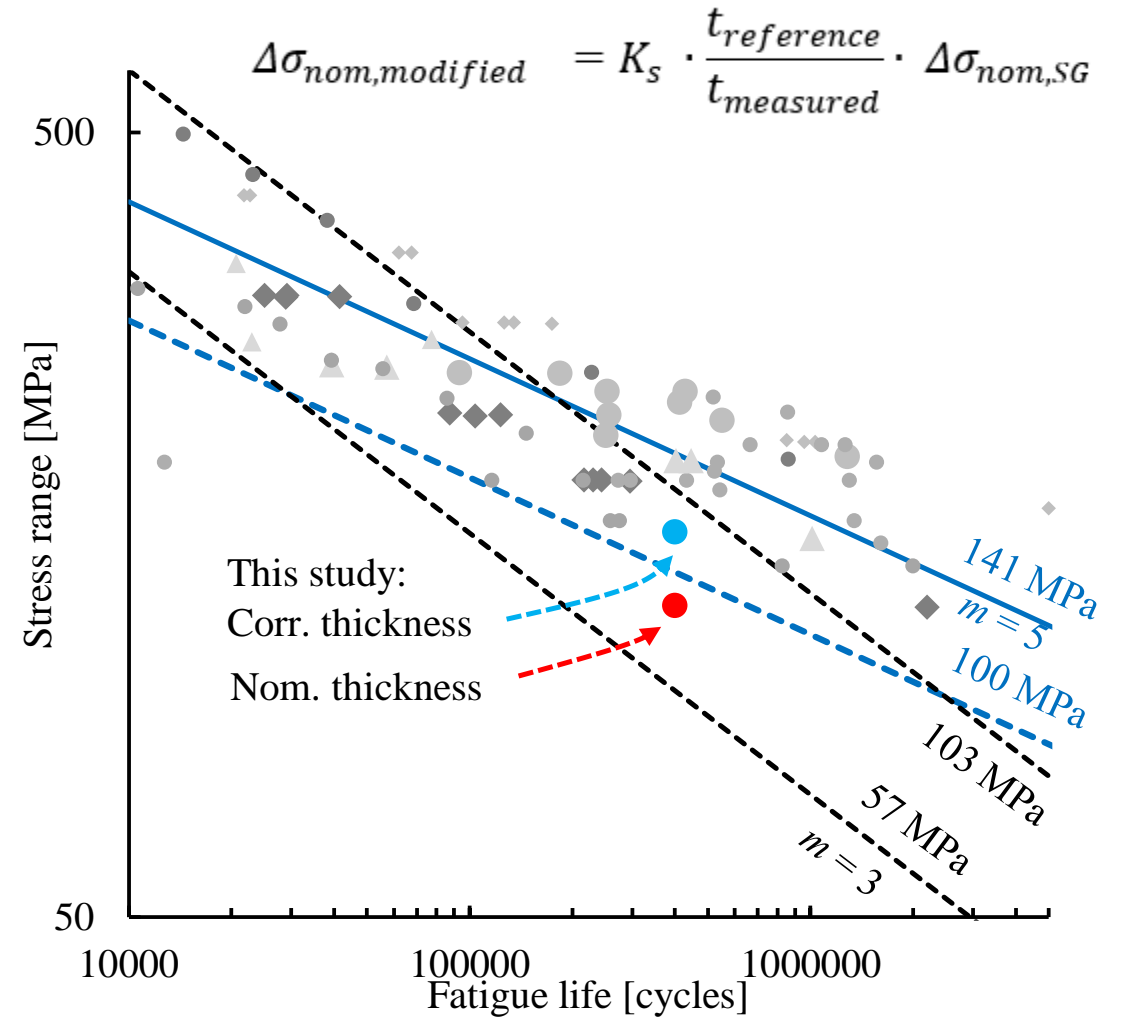
# DED FATIGUE STRENGTH ANALYSIS

- The strength after considering local thickness decrease inline with our previous study findings
- Fatigue performance based on FEA and SGs exceeding FAT 100 MPa  $m = 3$
- Imperfections and especially thickness reduction important to control or use more conservative fatigue strength assesment
